LA-UR-21-20833

Title: GRING18 Corrosion Characterization

GRING18 Corrosion Characterization

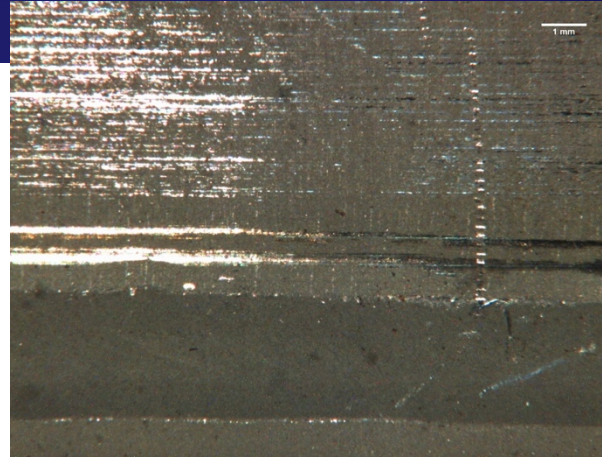
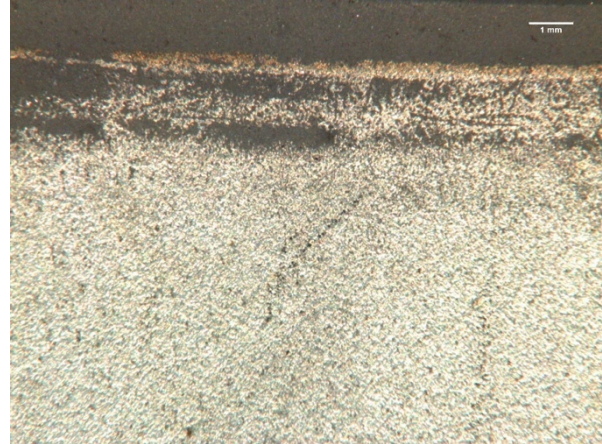
Machined area of wall has areas that appear dull due to general corrosion. The general corrosion extends for about 1 cm below the weld.

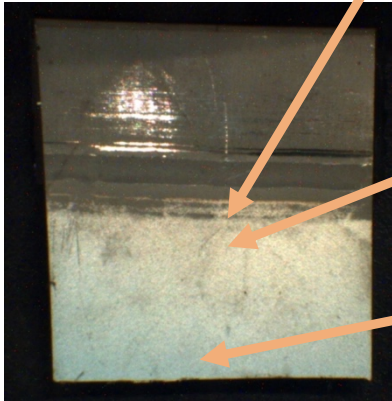
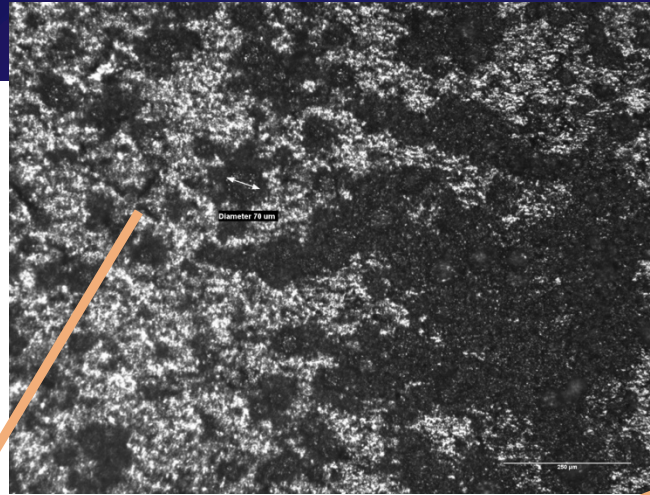
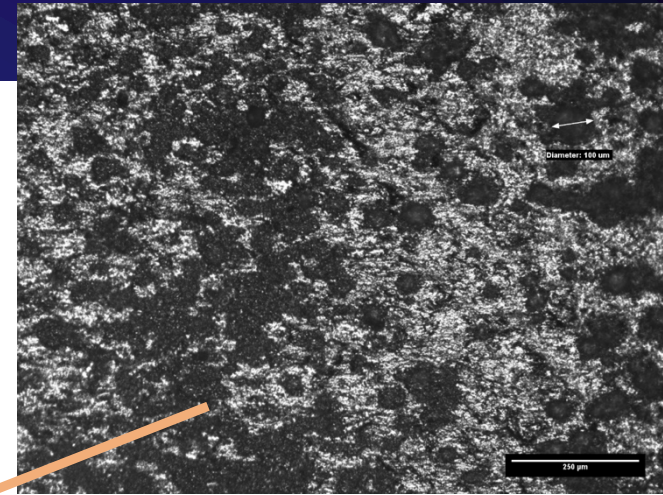
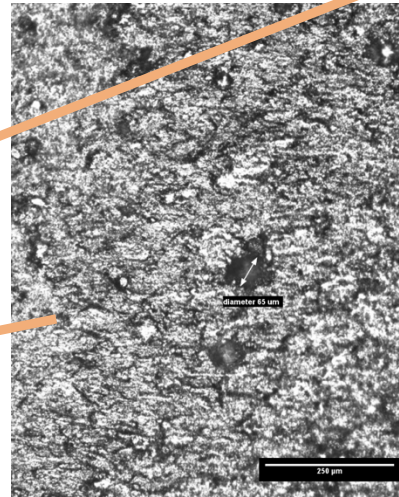
Just below the weld, the wall has eroded areas with numerous corrosion pits. Pits ranged in size from 40 up to 100 microns in diameter. The highest concentrations of pits were observed within 1 cm of the weld.

Ratio of depth/diameter is about 2

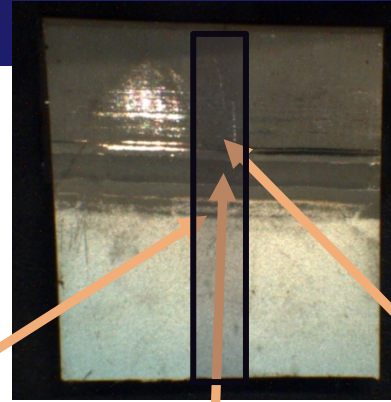
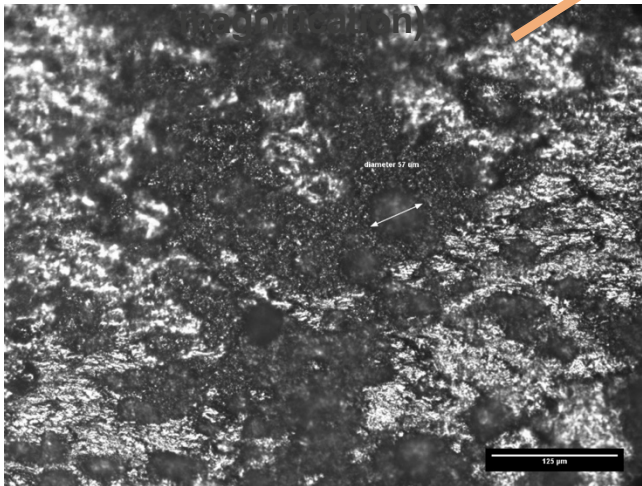
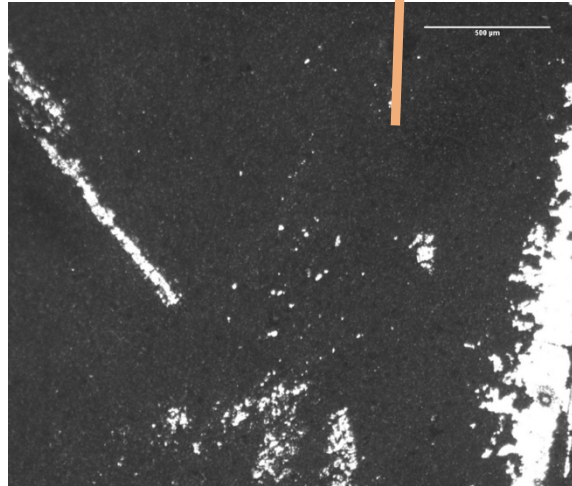
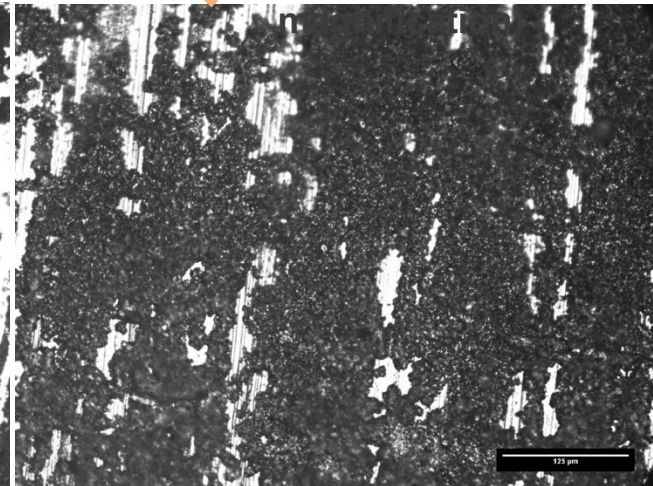
Largest pits observed just below weld.

No pits observed on weld.

Very small pits on machined surface above weld.

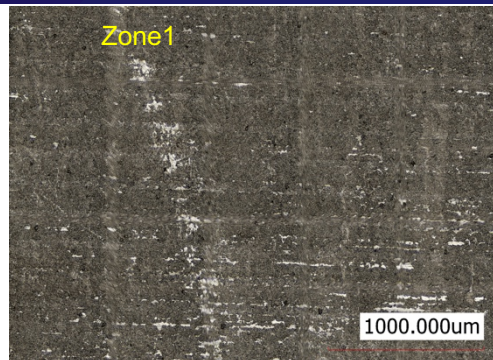
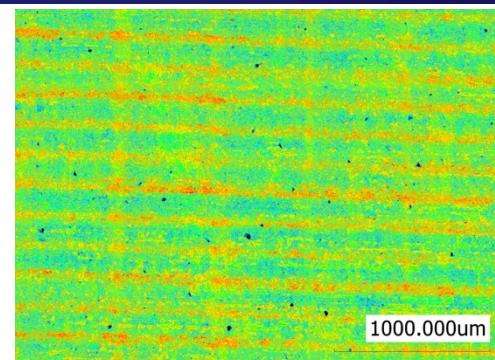
Small pits
Light surface corrosion

Corrosion appears to be different at both zones

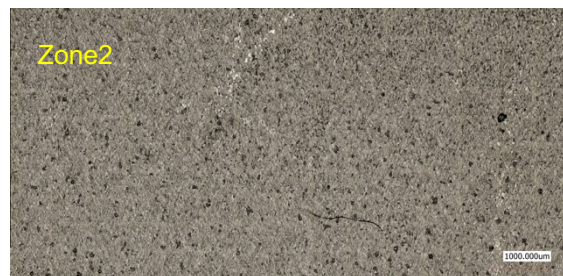
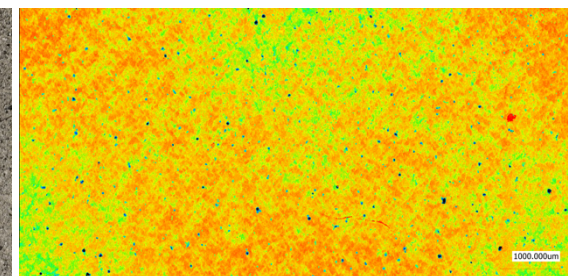
Larger pits
Lots of surface corrosion
Significant amount of pit agglomerate

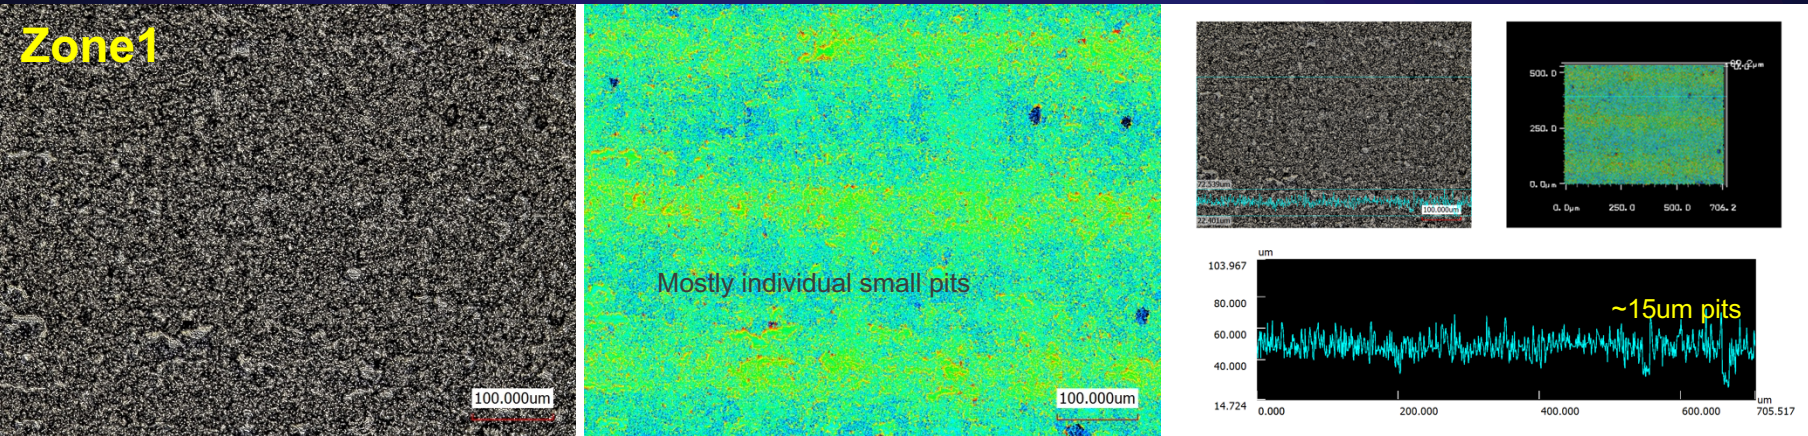
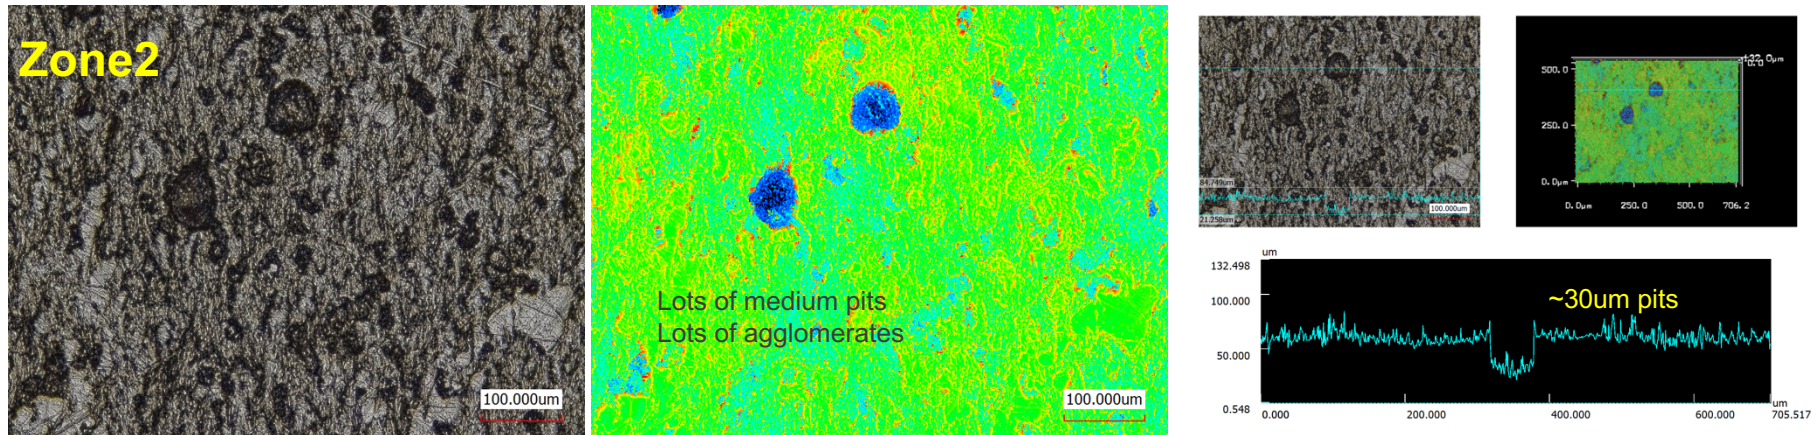
Surface Damage

Different surface finish
Appear to have different pit depths and diameters at different zones

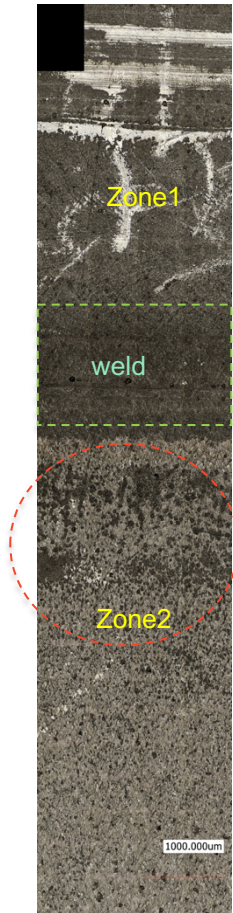
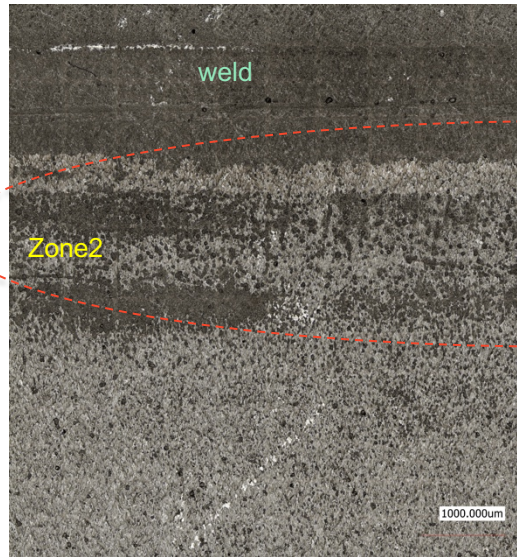
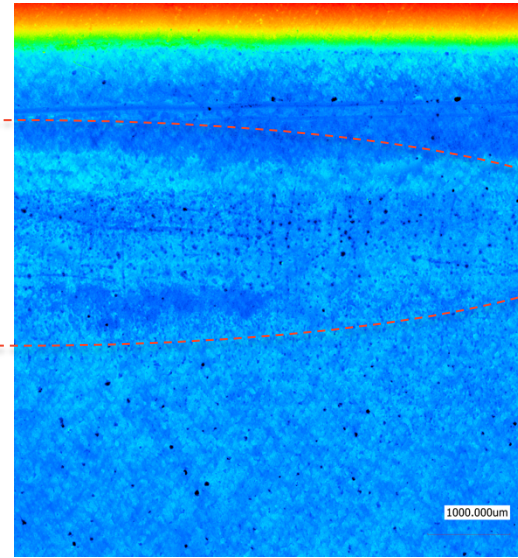
Corrosion Characteristics

Area with significant surface damage, ~1600 um from weld, most likely due to heat affected zone, however pit depths are similar to those below that area

For single pits, pit diameters:

- * Zone 1 are from few microns up to 30um
- * Zone 2 are from few microns up to ~85um

Lots of pit agglomerates in zone-2

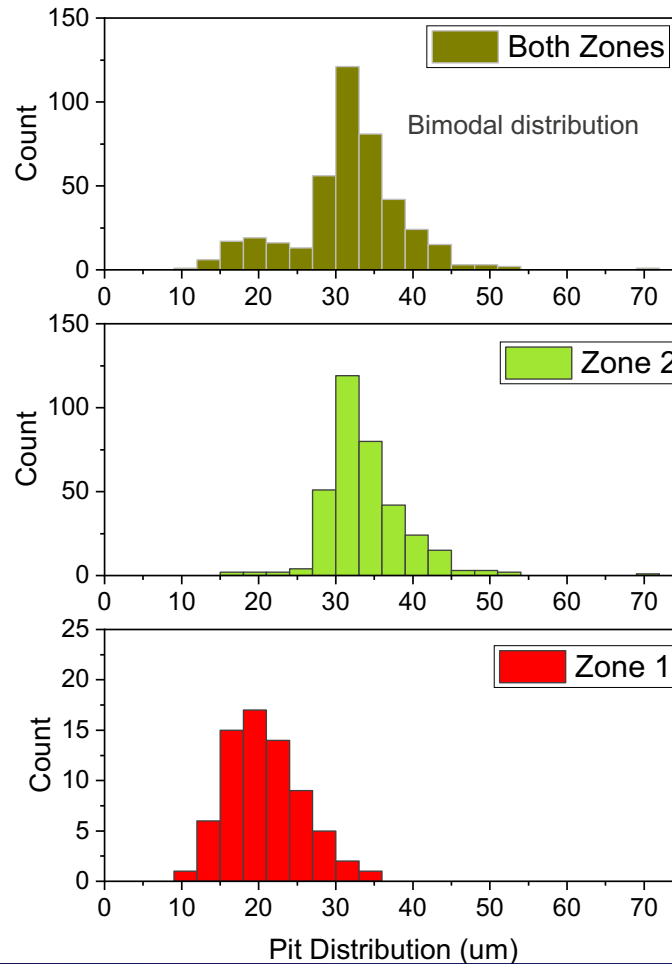
Pit Depth Statistics

- Bimodal pit distribution
- Indication that surface has a significant effect on corrosion

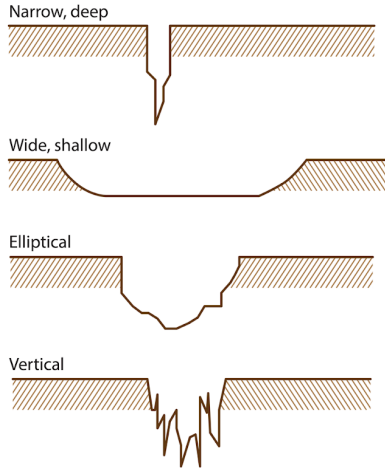
TROUGH PITS

Zone 1 pits tend to be deeper than they are wide.

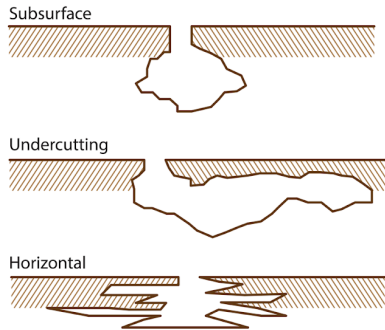
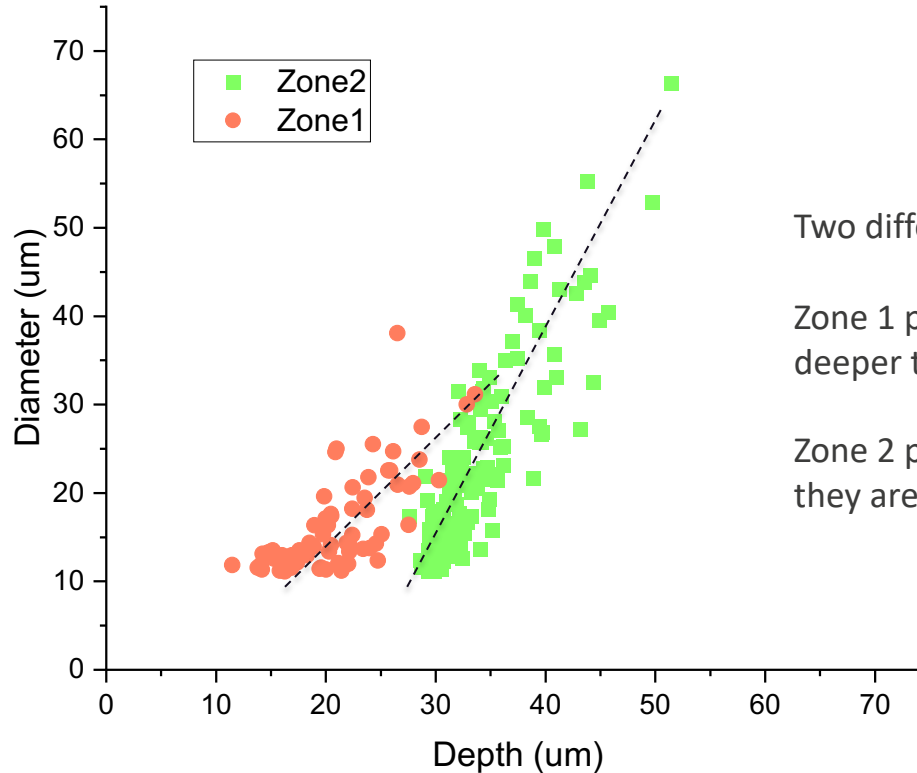
SIDEWAY PITS

Two different slopes

Zone 2 pits are wider than they are deep.
